# **LITTLE CHOCONUT WATERSHED SITE 2B DAM**

**BROOME COUNTY, NEW YORK  
INVENTORY No. NY 721**

## **PHASE I INSPECTION REPORT NATIONAL DAM SAFETY PROGRAM**

**NEW YORK DISTRICT, CORPS OF ENGINEERS  
FEBRUARY 1981**

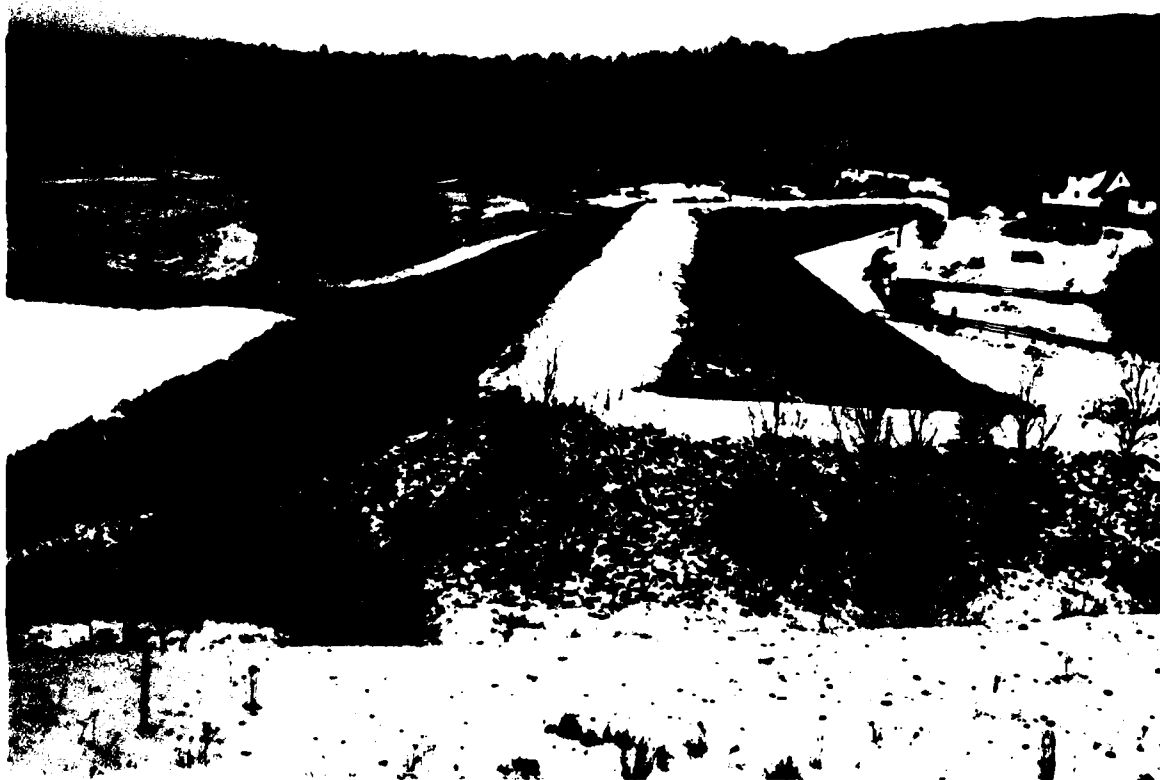
PHOTO #1: Overview of  
Little Choconut Watershed Site 2B Dam  
Inventory No. NY 721

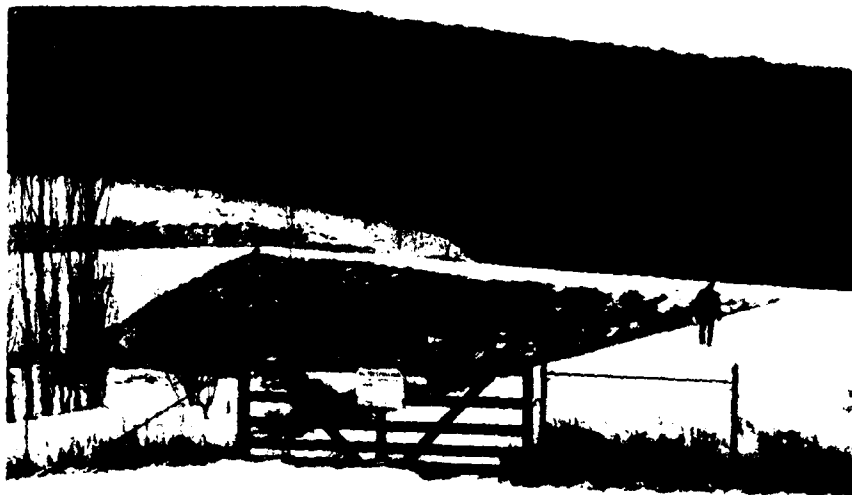
PHOTO #2: Overview of dam from left abutment

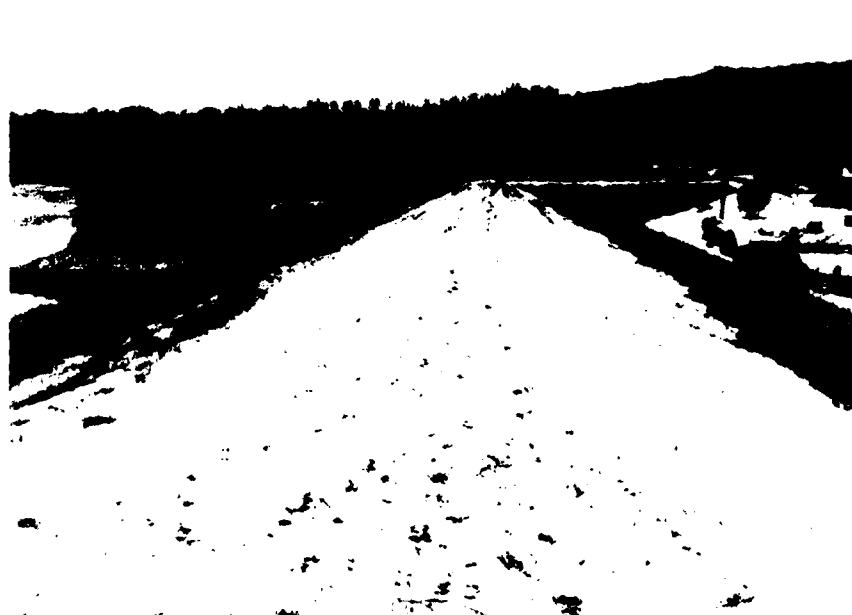
PHOTO #3: Crest of dam looking toward left abutment

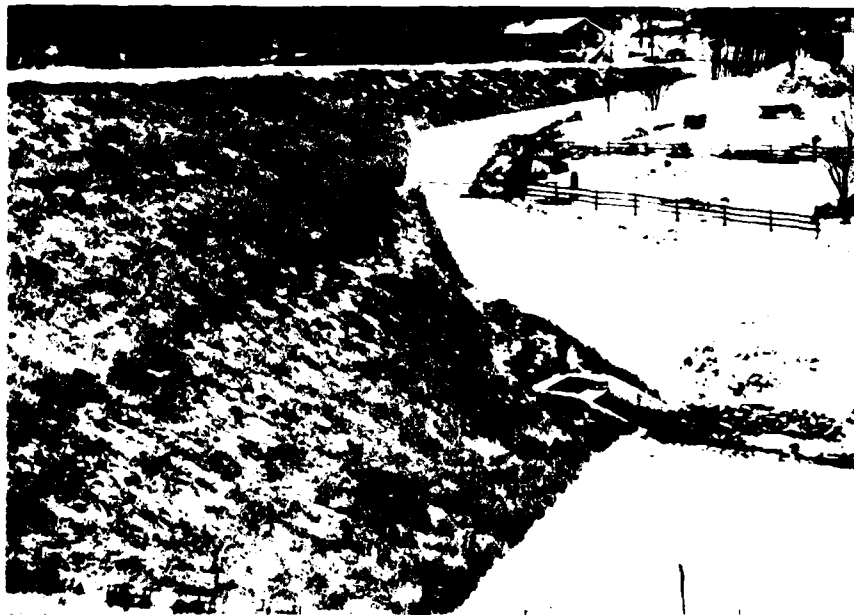
PHOTO #5: Overview of downstream face of dam

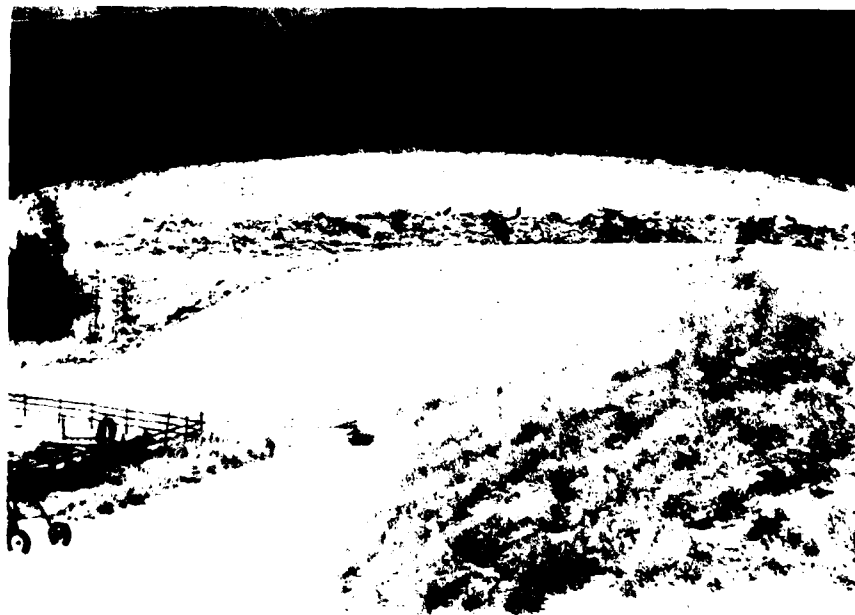
PHOTO #7: Downstream face of dam

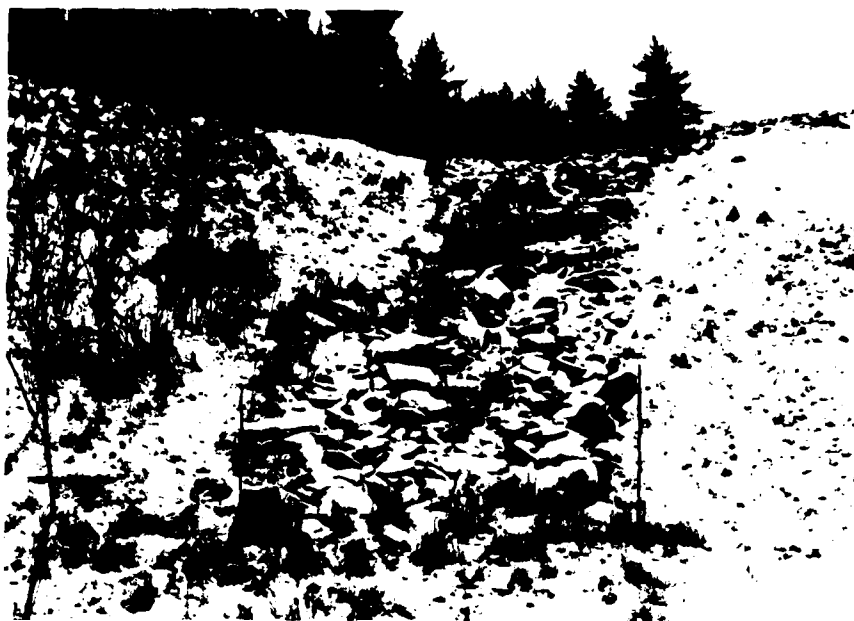
PHOTO #10: Emergency spillway outlet

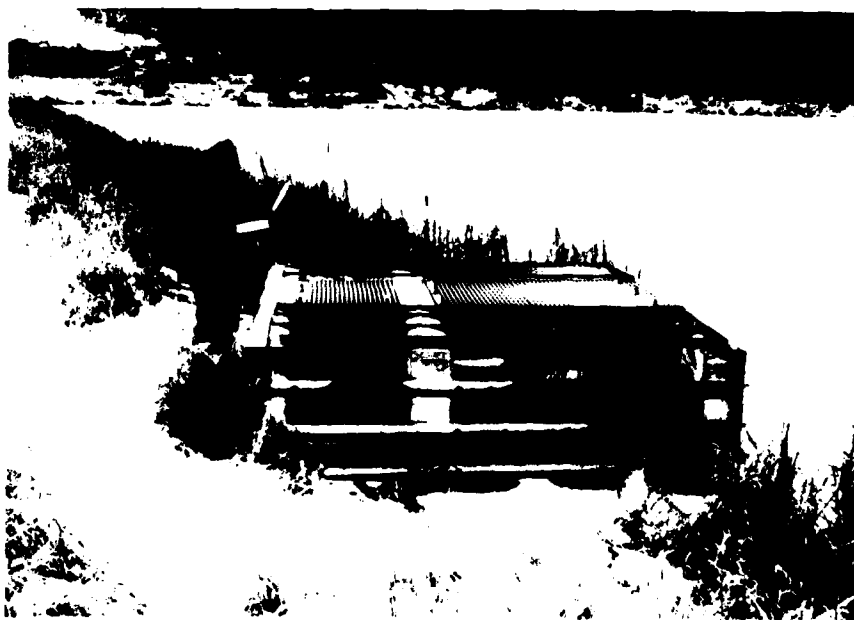
The reinforced concrete drop inlet structure is in excellent condition (See Photo No. 11). The inlet weir has a trash rack attached to it and was free of debris. A gate stem for a lower level inlet was observed but not operated during the inspection.

PHOTO #11: Drop inlet structure

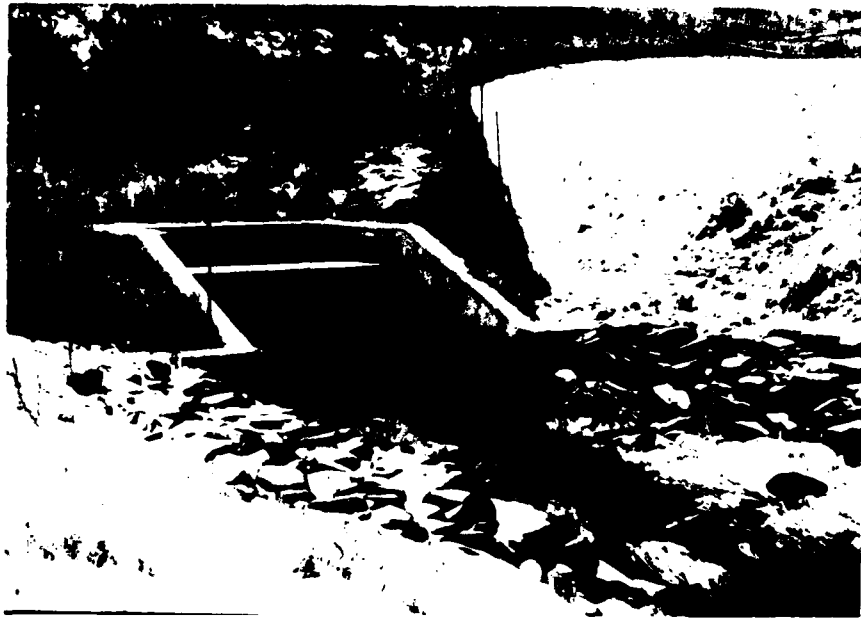
The principal spillway conduit discharges at a reinforced concrete impact basin used to dissipate the energy of high velocity discharge. Overall, the structure was in excellent condition (See Photo No. 12); however, some loose riprap has accumulated on the downstream concrete apron and the joint filler between the 30 inch PCCP and the impact basin has deteriorated.

PHOTO #12: Outlet works: Impact basin

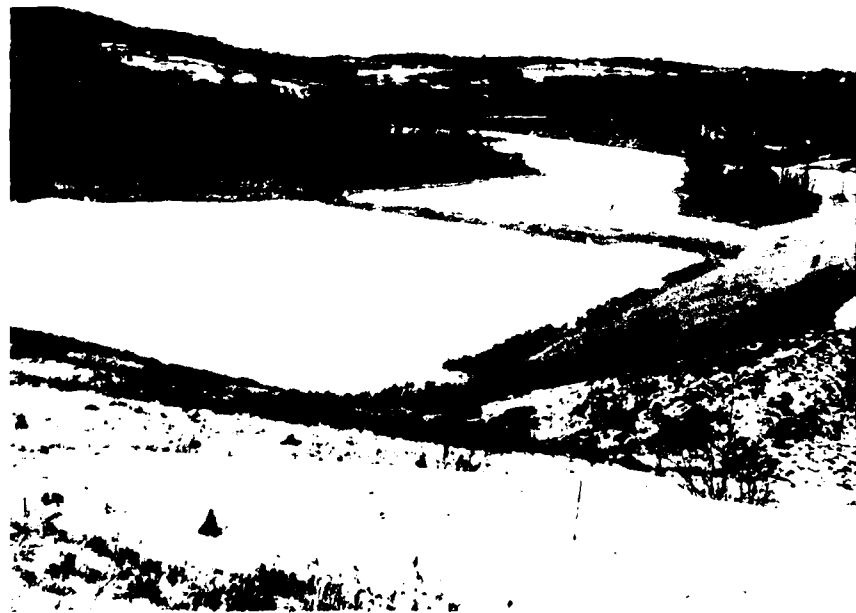
PHOTO #15: Impoundment
